Cable Routing Issue

Bikes Affected: 2016A Models

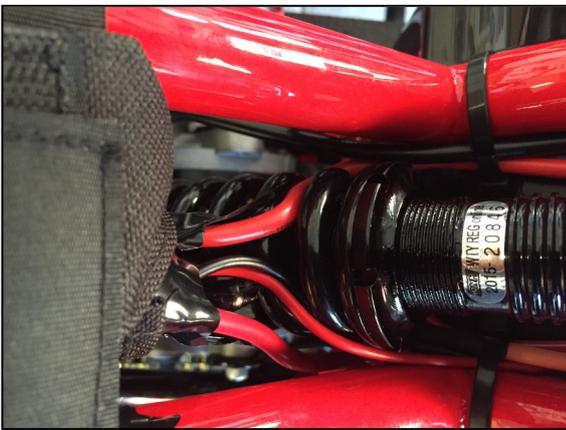
It has come to our attention that during assembly of the latest 2016A shipment, the cable routing on some bikes is slightly different to our original specification. Whilst it is a minor change, it could lead to premature wear or disconnection of electrical components.

As shown in Figure 1 below, the wiring to and from the relay have been routed too close to the rear shock unit. On some affected models these wires could become caught in the coils of the spring and cause them to rub, or disconnect from the relay.

Figure 1. Potential issue of cable routing becoming caught in the coils of the rear shock spring.

We would ask you to check all bikes before they leave your showroom and where necessary use cable ties to secure the wiring to the frame, ensuring all wires are clear of the rear shock unit as shown in **Figure 2**. This should include wires to and from the relay, battery & motor.

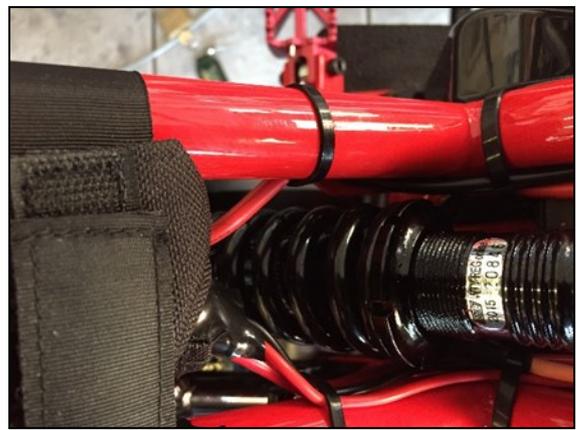
Figure 2. Solution of issue, all wiring securely cable tied to frame, well clear of rear shock unit.
