Preventing failure of the Li-Ion charger by improper plug disconnection.

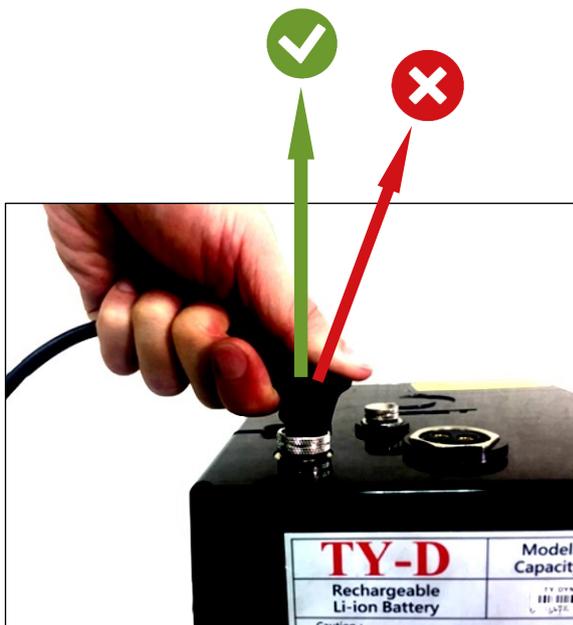
Pulling the plug out at an angle (as shown in Figure 1.) can result in a damaged cable (Fig 2.) and equipment failure. Some of the charger leads are tight, so applying silicone spray can aid fitment and removal.

Fig 1.) **Correct** disconnection of the charging lead.

When disconnecting a Li-Ion charger from an OSET battery pack, please ensure the plug is unscrewed, lifted straight up and out of the charging port on the battery.

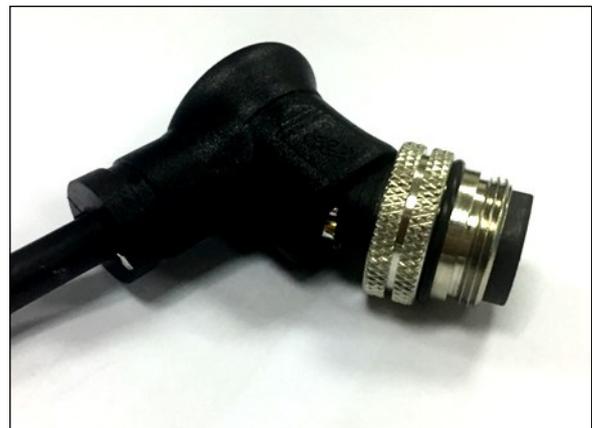
It has come to our attention that some Li-Ion chargers have failed prematurely due to misuse of the charging plug & lead.

Fig 2.) Subsequent damage caused by improper use.

*Also please **do not** attempt to lift or carry the battery via a connecting charging lead / plug as this can have the same effect & damage the equipment.*
